LEAD - HAZARD FREE CERTIFICATE

LEAD PAINT INSPECTION REPORT

REPORT NUMBER: S#01404 - 09/20/24 11:29

INSPECTION FOR: Helping Hands Child Care Center
300 Pleasant Vally Way
West Orange, NJ 07052
Phone:

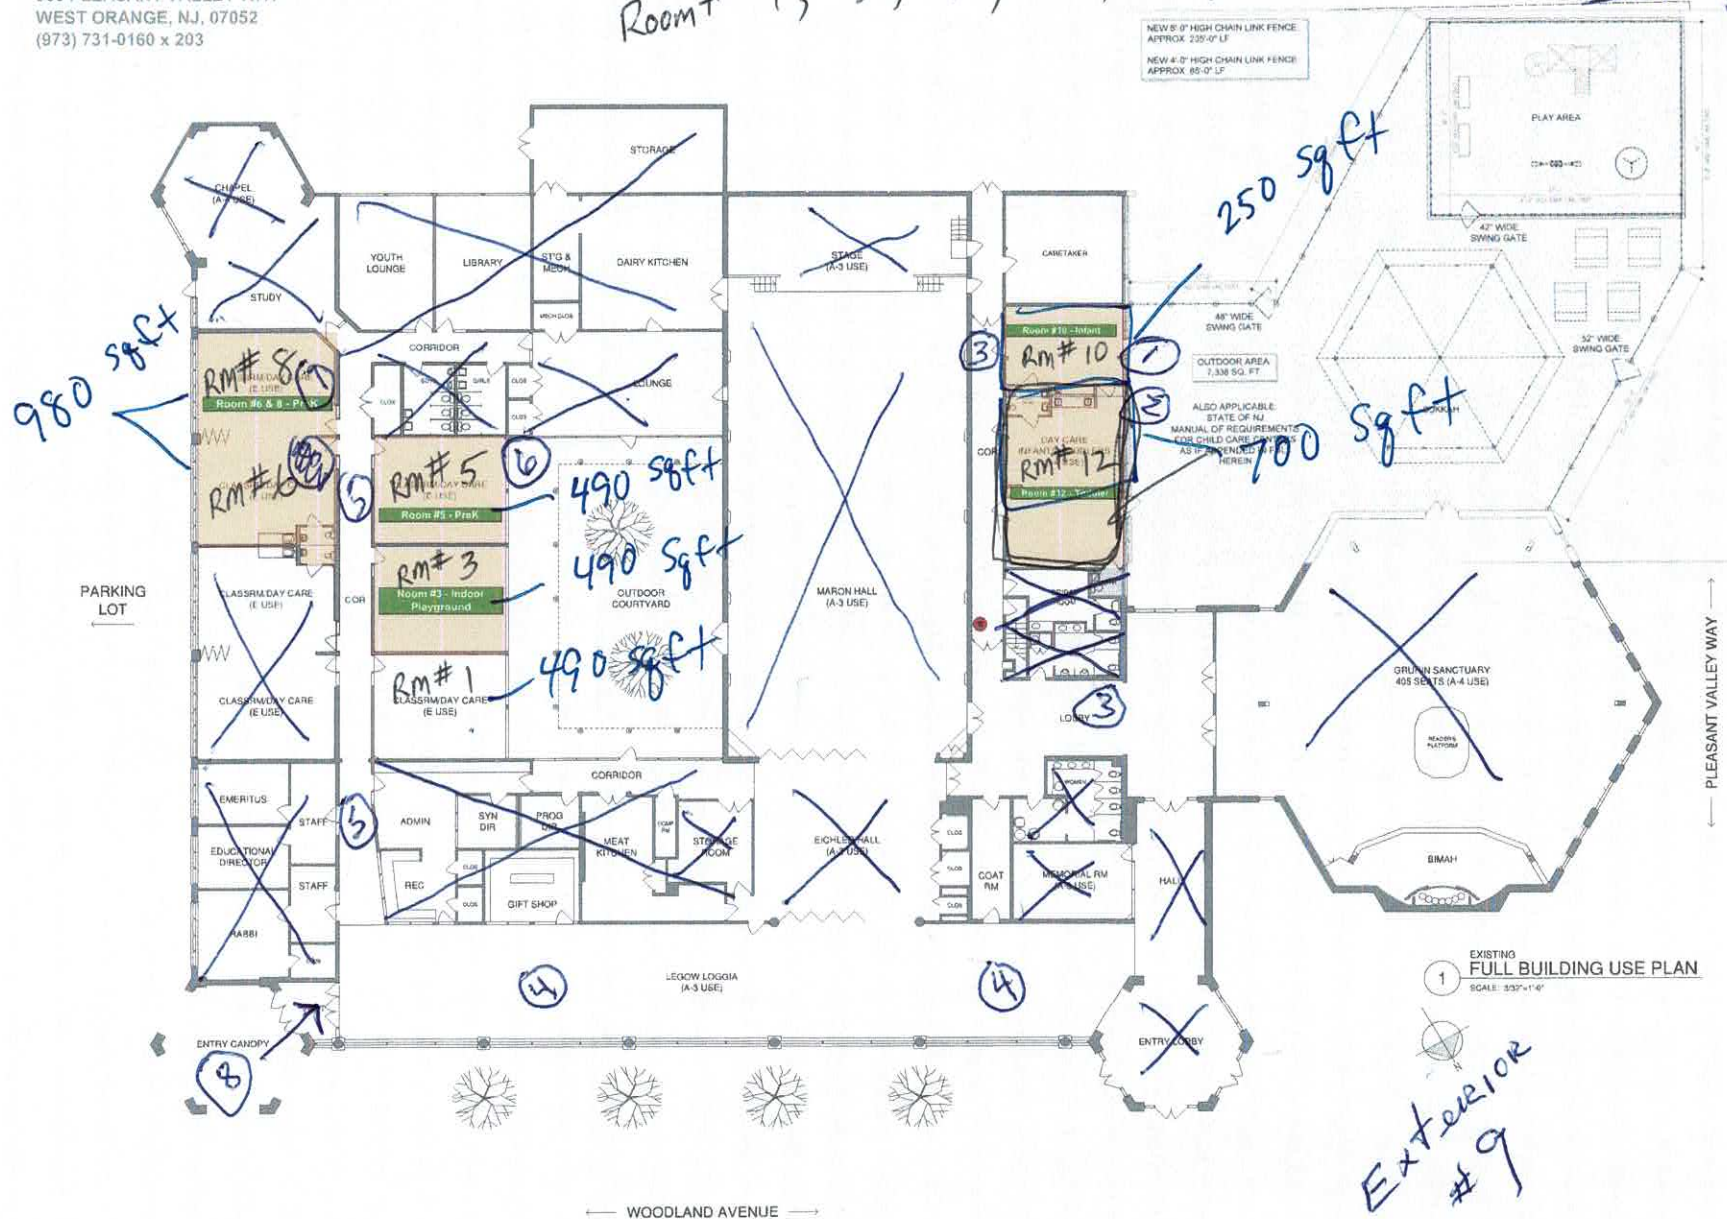
Room# 1, 3, 5, 6, 8, 10, 12

Ext 9
